Manhole Inspection Summary

Manhole # S2901_006MH

Insp Date: **2/19/08 8:52 AM**

Location Address: **819 Carver Rd.**

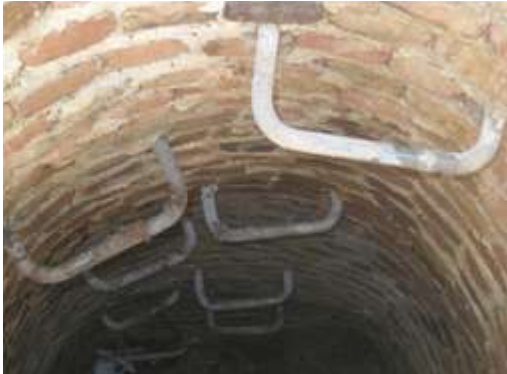
Steps

☒ **Corroded**

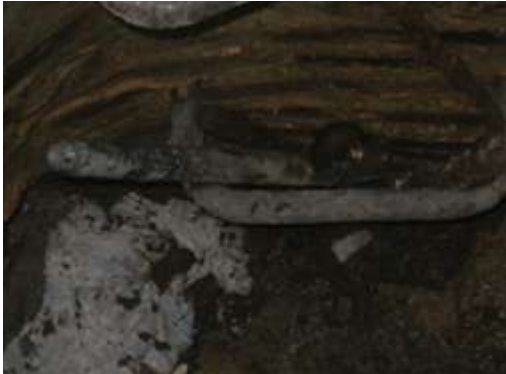
Defect 2

Pole in step

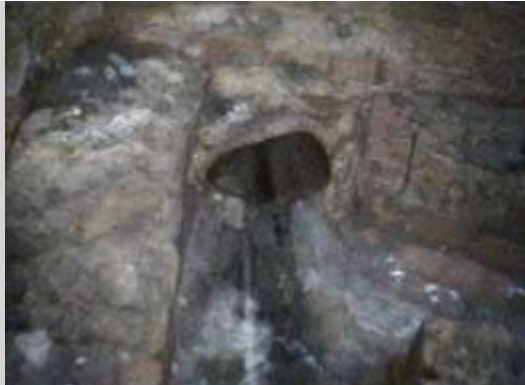
12 O'Clock Outflow

8 in. Circular Gravity Sewer
Pipe Out @ 12 O'Clock

Pipe Height: **10.8** (in.) Rod and Bar (Angled)
Pipe Material: **Clay** ☐ Pipe Lined
Invert Depth: **13.24** (ft.) Flow Characteristics: **None**
Deposits: ☒ None ☐ Mud ☐ Sludge ☐ Debris ☐ Grease
Silt Depth: (in.) Deposits Extent:
Infiltration: **None** Pipe Seal Cond: **Sound**

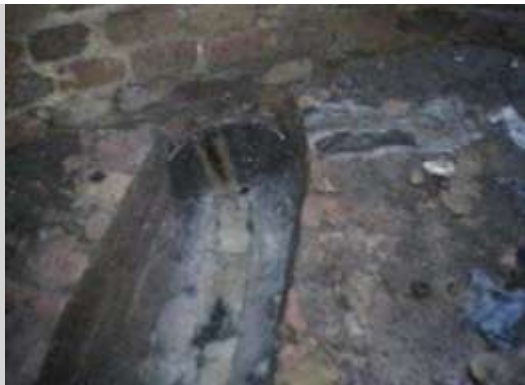
3 O'Clock Inflow

10 in. Circular Service Sewer
Pipe In @ 3 O'Clock

Pipe Height: **9.6** (in.) Rod and Bar (Angled)
Pipe Material: **Clay** ☐ Pipe Lined
Invert Depth: **12.96** (ft.) Flow Characteristics: **None**
Deposits: ☒ None ☐ Mud ☐ Sludge ☐ Debris ☐ Grease
Silt Depth: (in.) Deposits Extent:
Infiltration: **None** Pipe Seal Cond: **Sound**

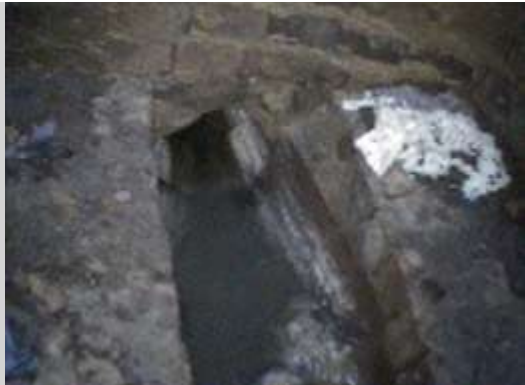
6 O'Clock Inflow

8 in. Circular Gravity Sewer

Pipe In @ 6 O'Clock

Pipe Height: **10.8** (in.) Rod and Bar (Angled)

Infiltration: **None** Pipe Seal Cond: **Sound**
